Road Safety Inspection of the Kampala-Malaba Highway

A Baseline Study

Prepared by
Godfrey Mwesige
Safety and traffic engineer, Department of construction Economics and Management, MAKERERE UNIVERSITY
feedback@safewayrightway.org

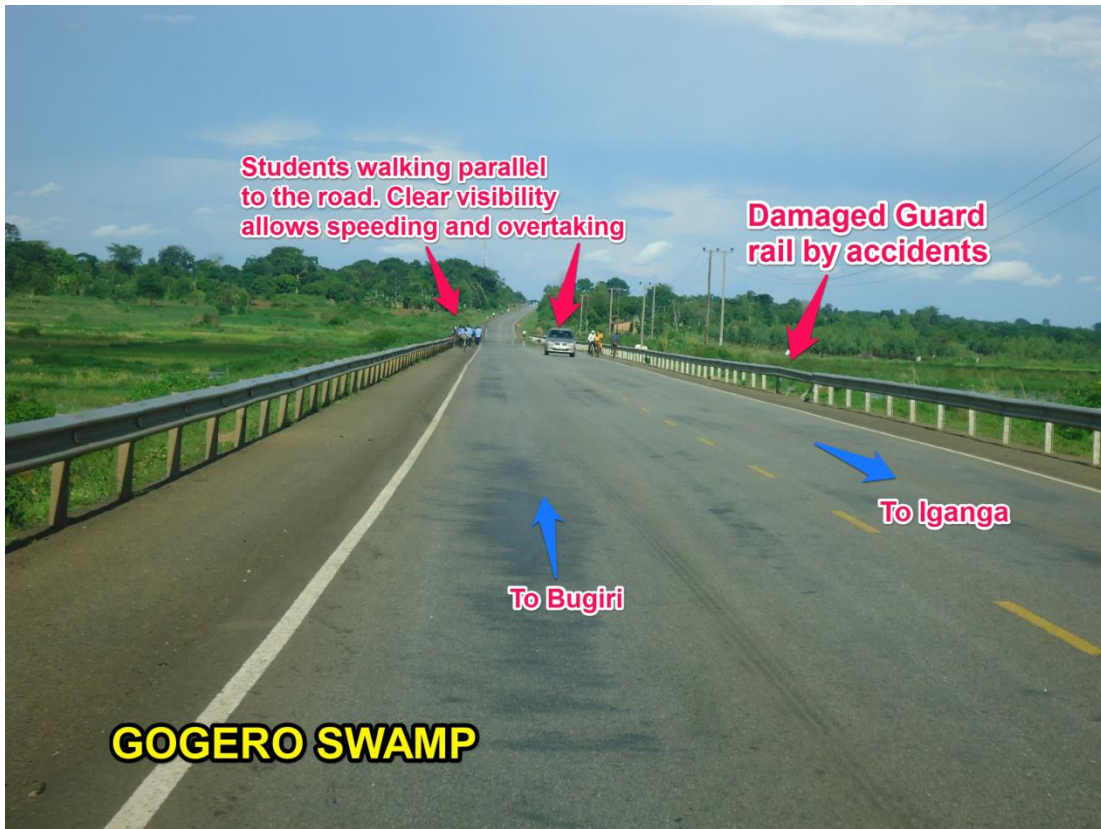
NDIFAKULYA PS

Pupils move parallel to a high speed highway after school.
