# ROAD SAFETY INSPECTION OF KAMPALA-HOIMA ROAD

## A Baseline Study

**Consultant:**  
Integrated Transport System Ltd  
9<sup>th</sup> Floor, Workers House  
Pilkington Road, Kampala, Uganda

October 2015

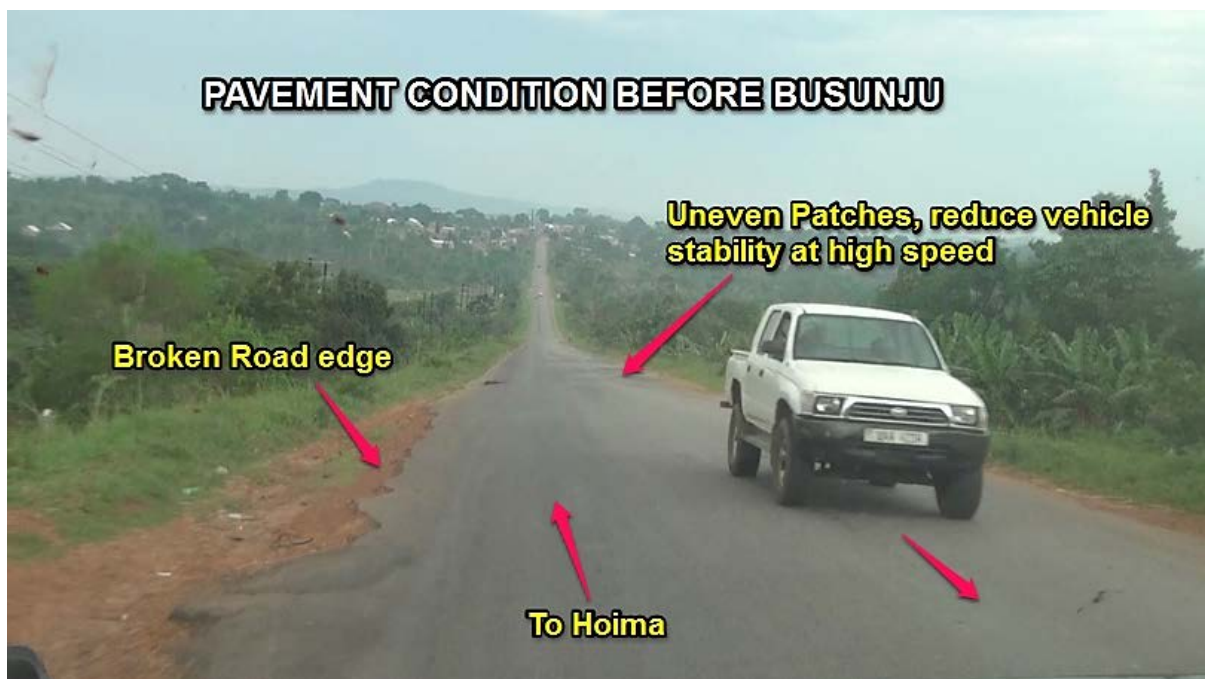
**Figure 2: Typical Pavement Condition of Kampala-Busunju Road Section**

Kampala-Hoima Road is 190 km between the Northern By-pass in Kampala and Hoima-Masindi Junction near Hoima Town. The road has an average lane width of 3.0 meters and variable shoulder width. The section between Kampala and Busunju is heavily patched and uneven. This reduces riding comfort and the possibility to attain high speeds. Rehabilitation of this section has commenced by the Uganda National Roads Authority (UNRA), and therefore expected to improve in the future. Figure 2 shows typical pavement condition of Kampala-Busunju section.

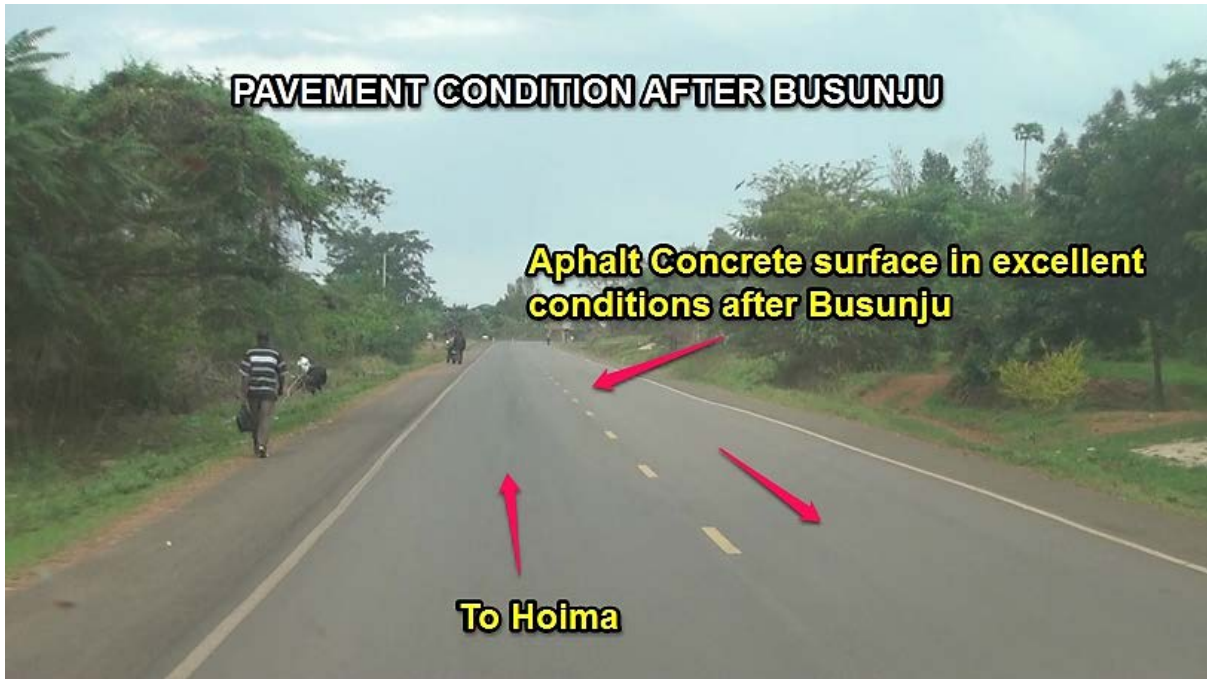
Figure 3: Typical Pavement Condition of Busunju-Hoima Road Section

The pavement surface of Busunju-Hoima section has asphalt concrete in good condition. The average lane width is 3.0 meters and variable shoulder widths 1.0-1.50 meters. There are several trading centers along this section and rumble strips before and after the trading centre to calm speeds to 50 km/h. The speed limit at non-built-up areas is 80 km/h for both passenger cars and trucks. However, due to a wavy alignment, it is not safe to drive at speeds higher than 80 km/h in the section between Busunju and Kiboga Towns. Figure 3 shows typical pavement condition of Busunju-Hoima Road.

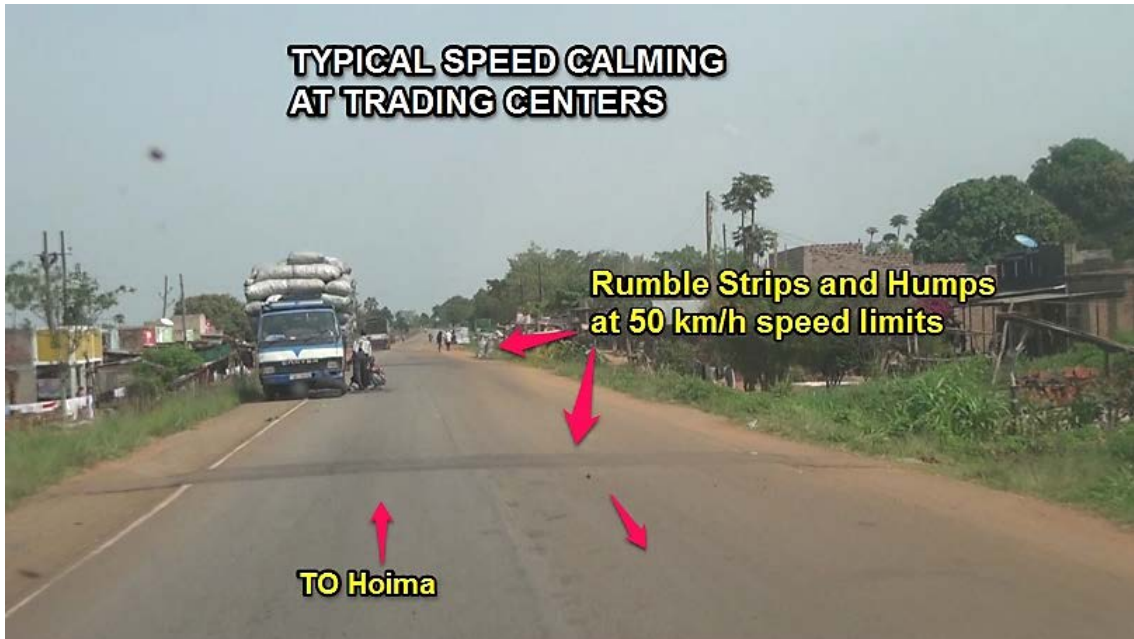
**Figure 6: Typical speed calming at several trading centers along Kampala-Hoima Road**  
*(GPS track overlay on Map Quest)*

Figures 5a and 5b show speed profiles of Kampala to Hoima Road. The average travel speeds along the section is between 80-90 km/h. Safer speeds slightly above 80 km/h are possible after Kiboga Town due to less meandering of the horizontal alignment, reduced roadside activity and decreasing elevation levels (see Figure 5a). Generally, it is risky to travel at speeds more than 80 km/h along the entire road. Figure 5b shows the increased noise in the speed profile. This is due to stop and go phenomenon at trading centers as a result of rumble strips and sharp curves with limited visibility along the alignment between Busunju and Hoima Town. Figure 6 shows typical speed calming using rumble strips at Trading Centers to enforce 50 km/h speed limit. This contributes to routine reduction of speeds to 50 km/h more often along the road.

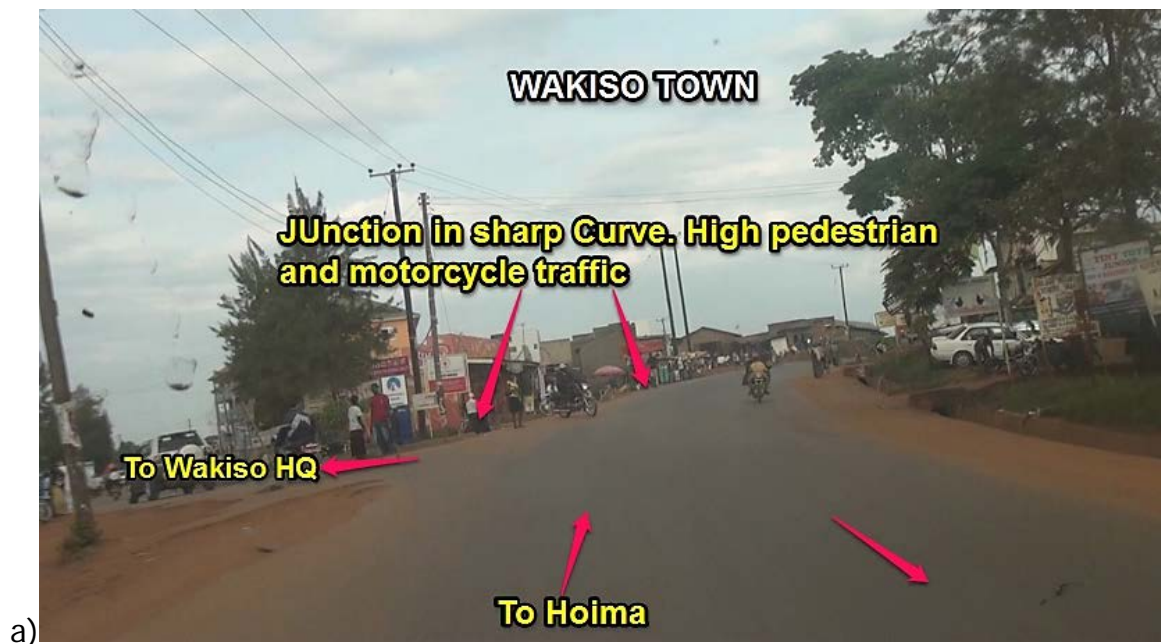
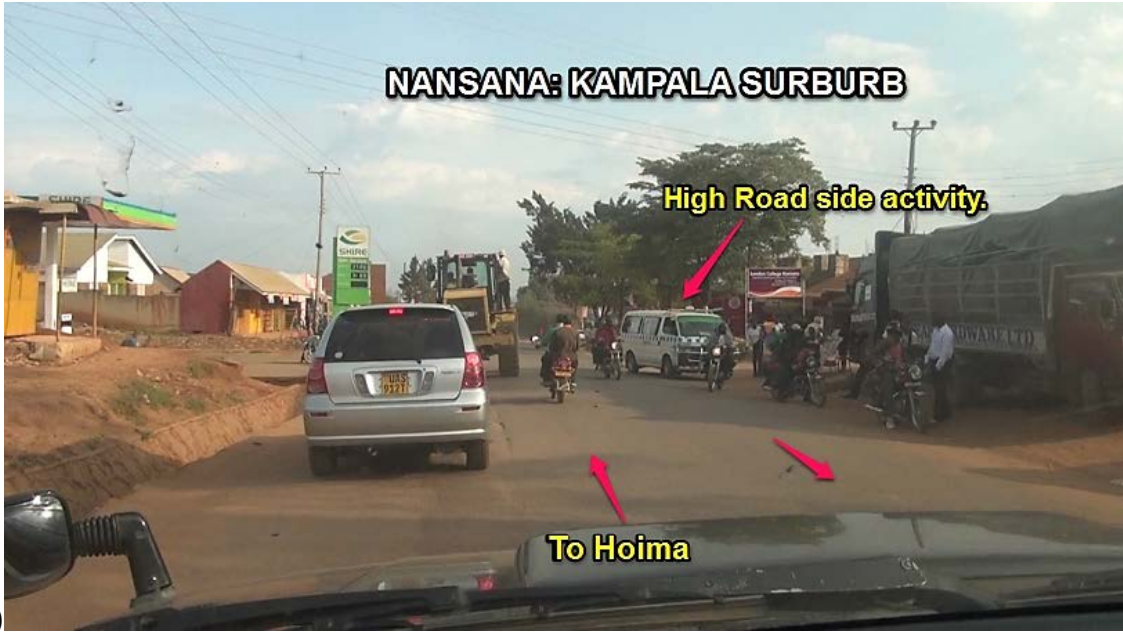
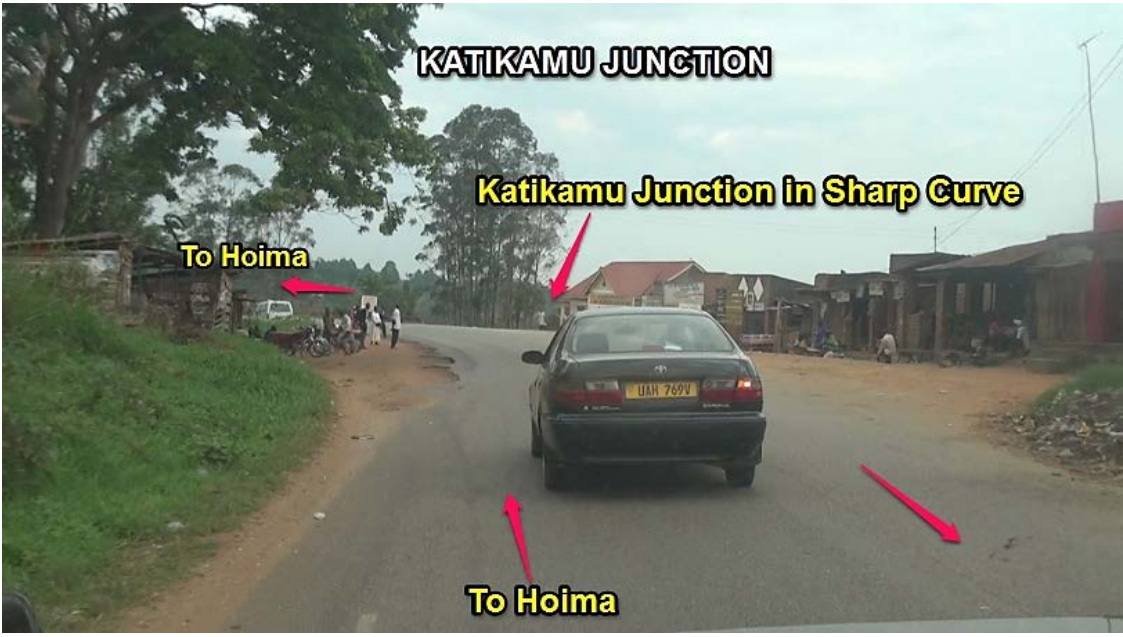
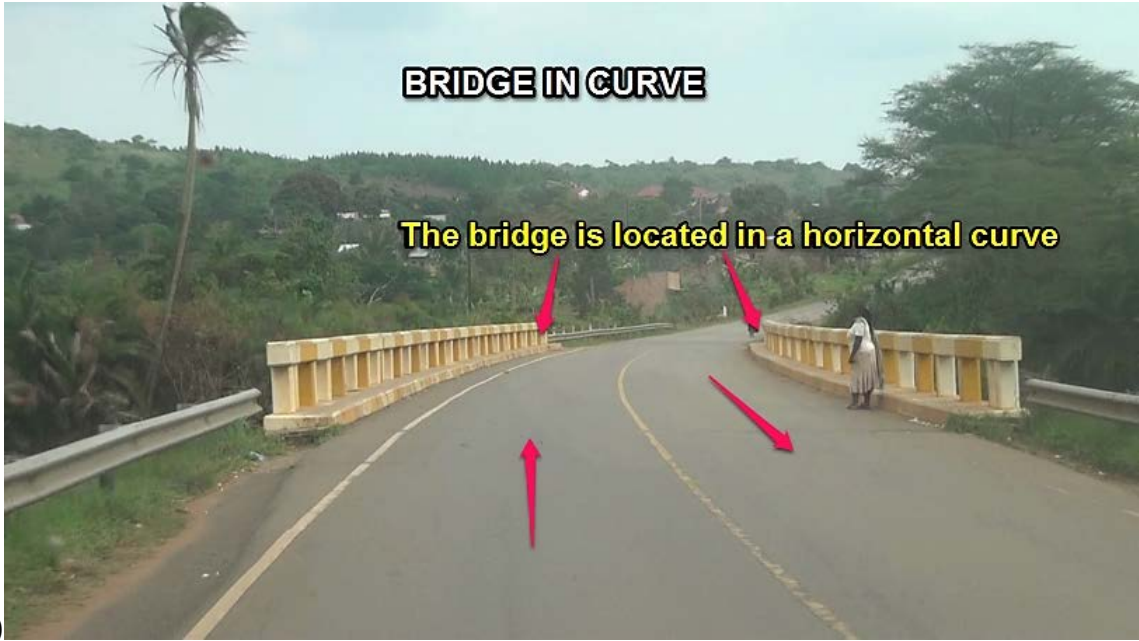
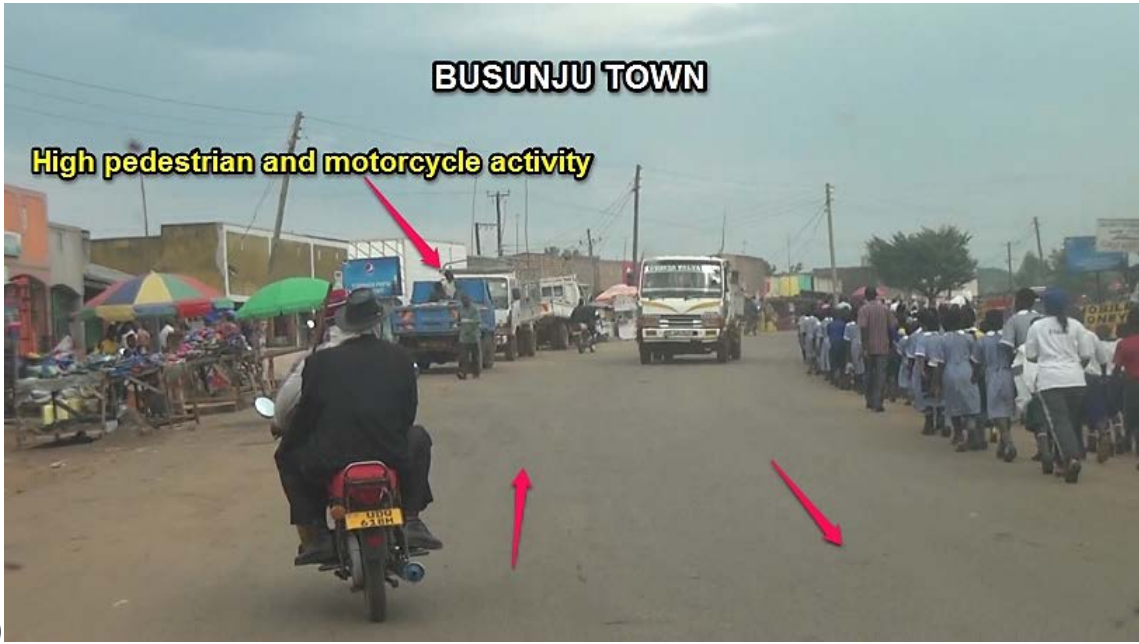
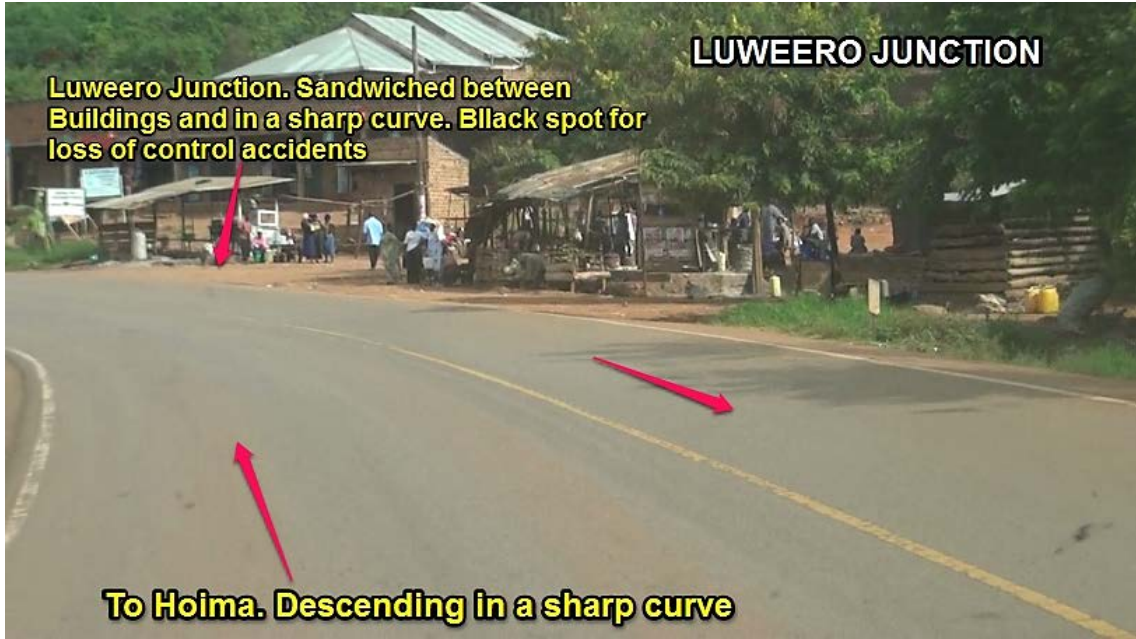
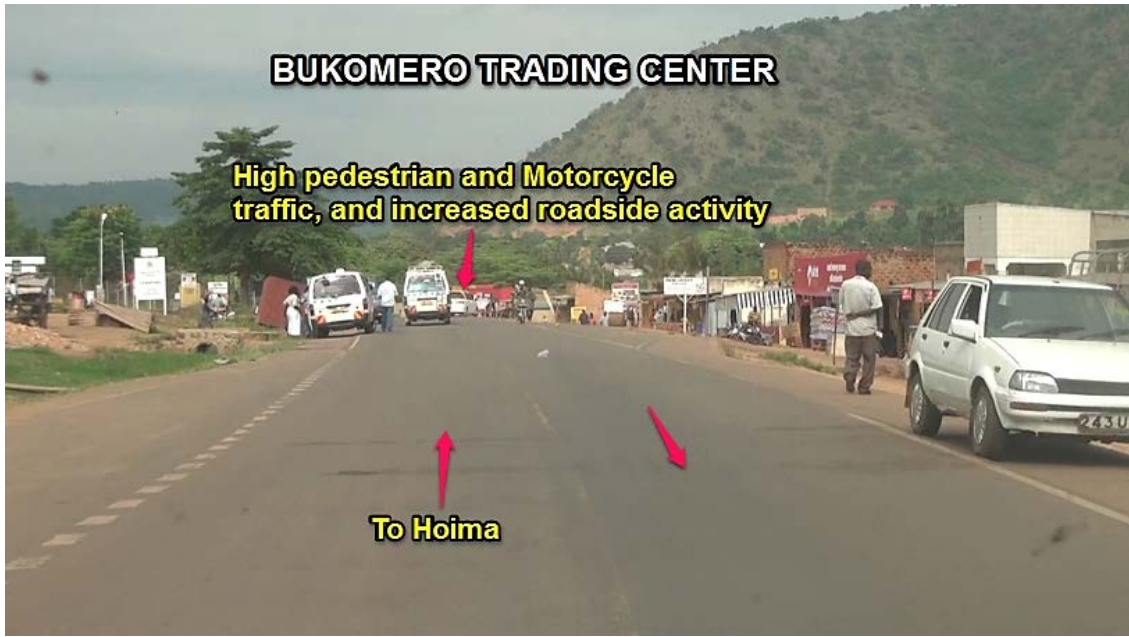
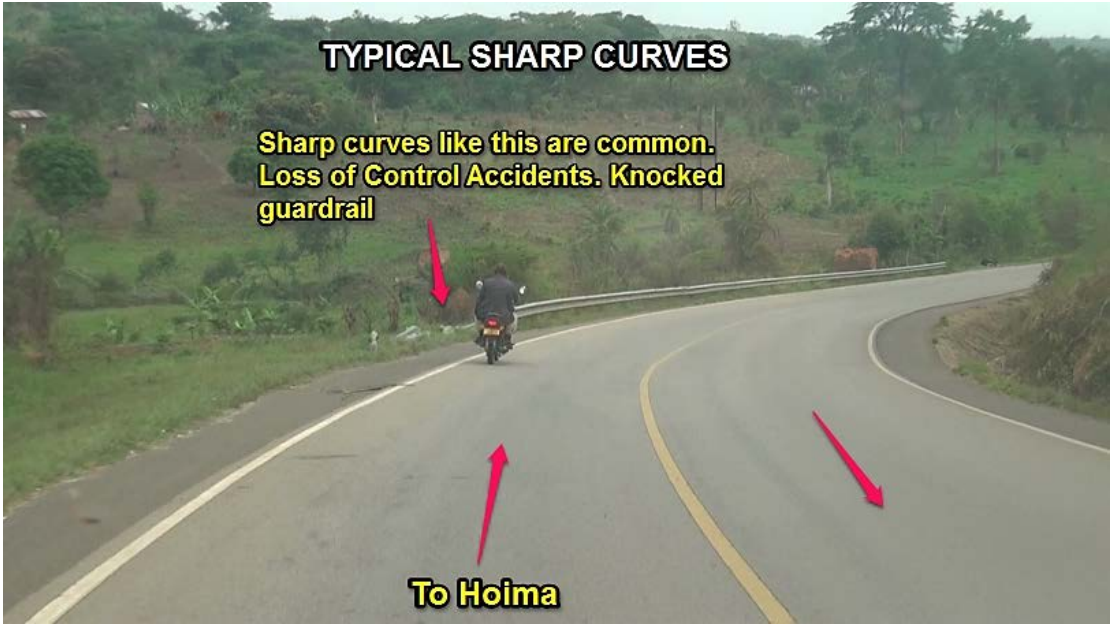
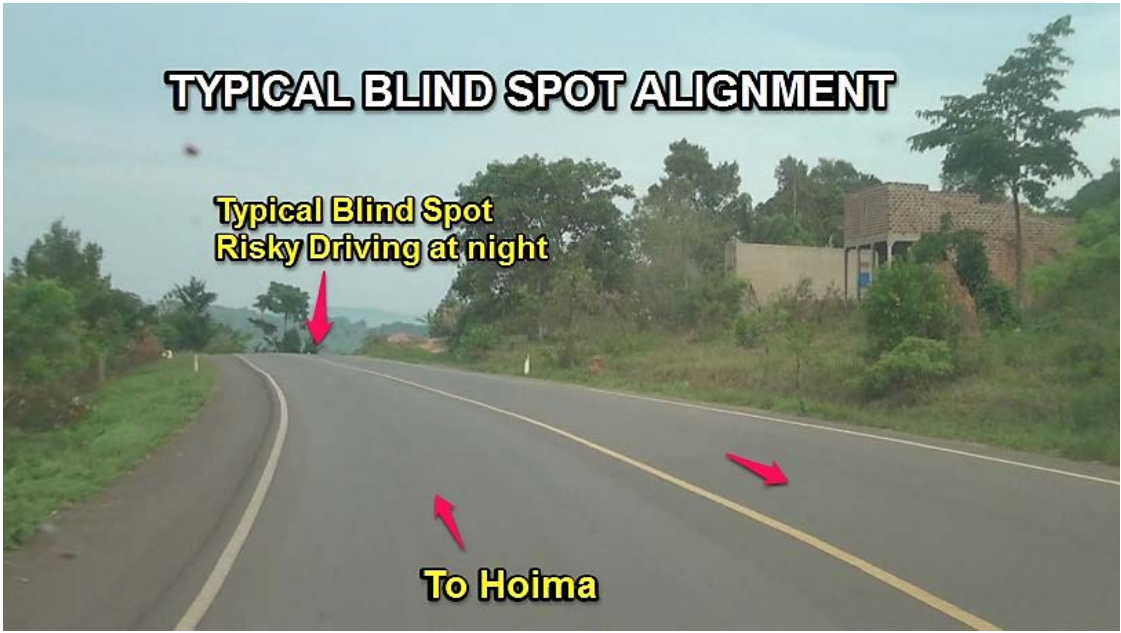
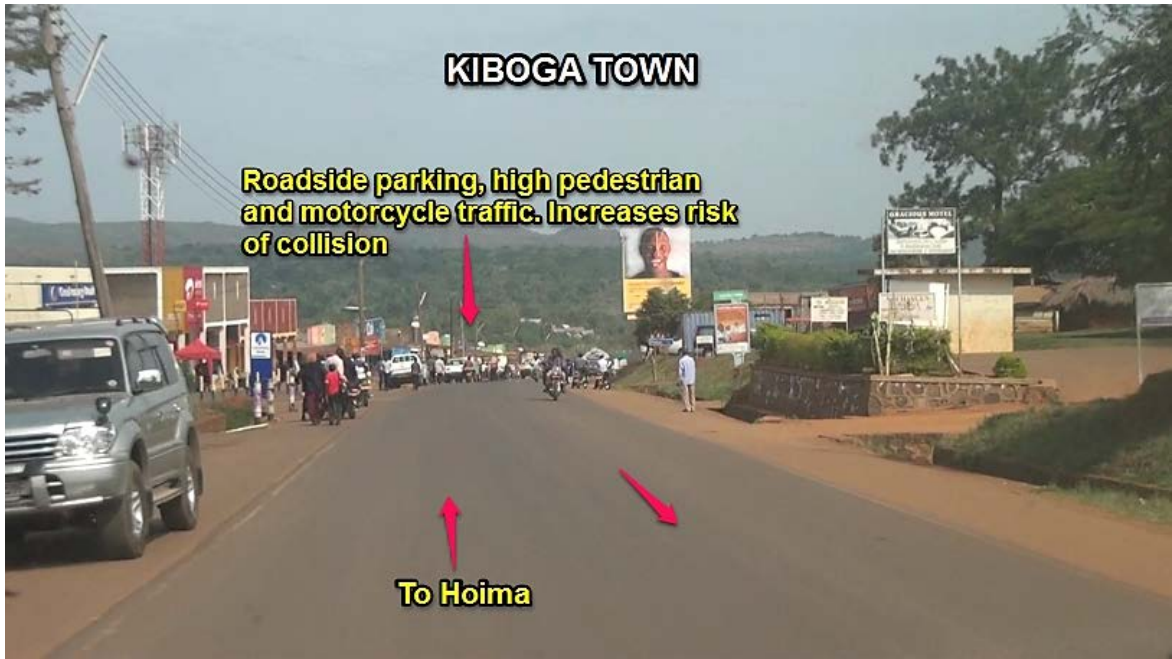
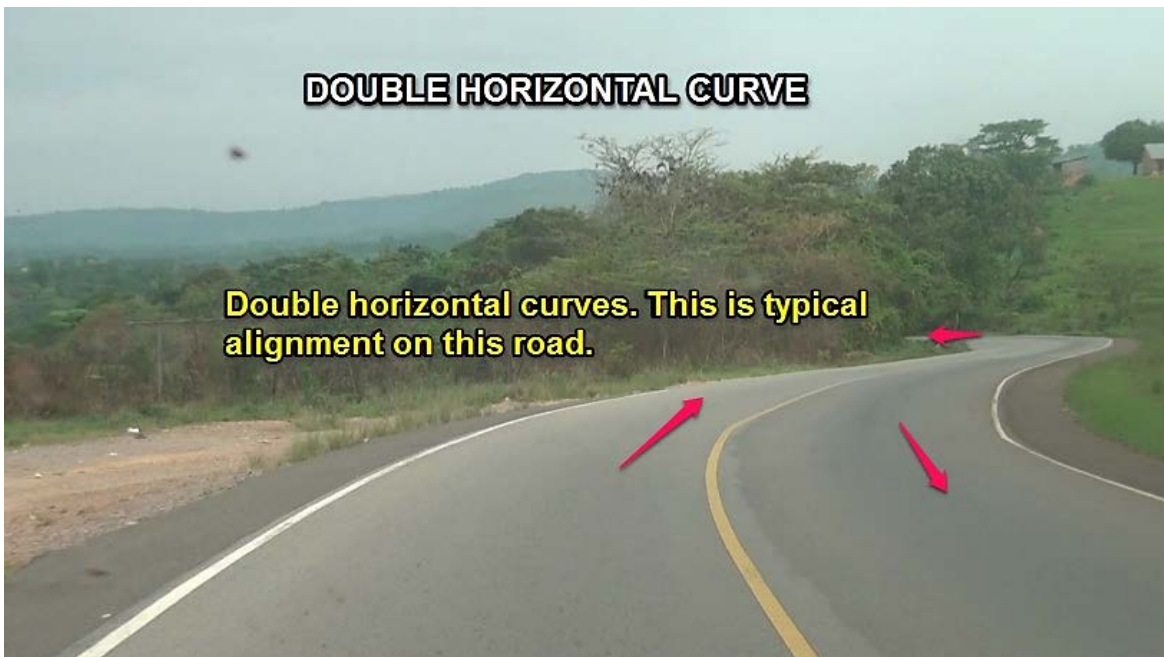
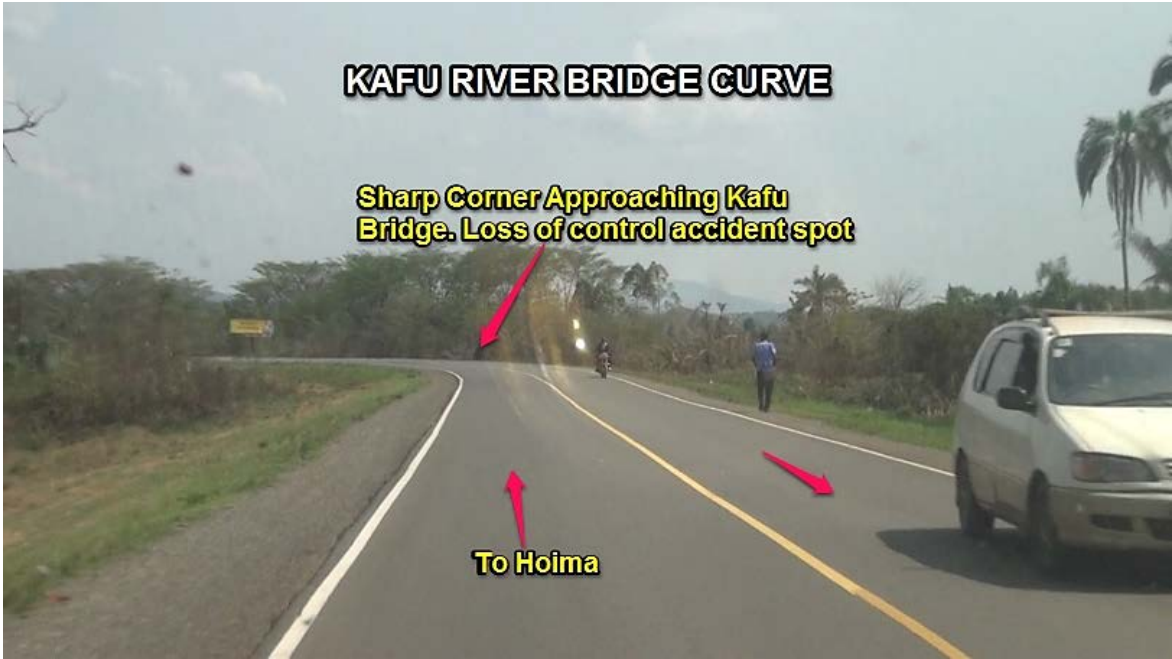
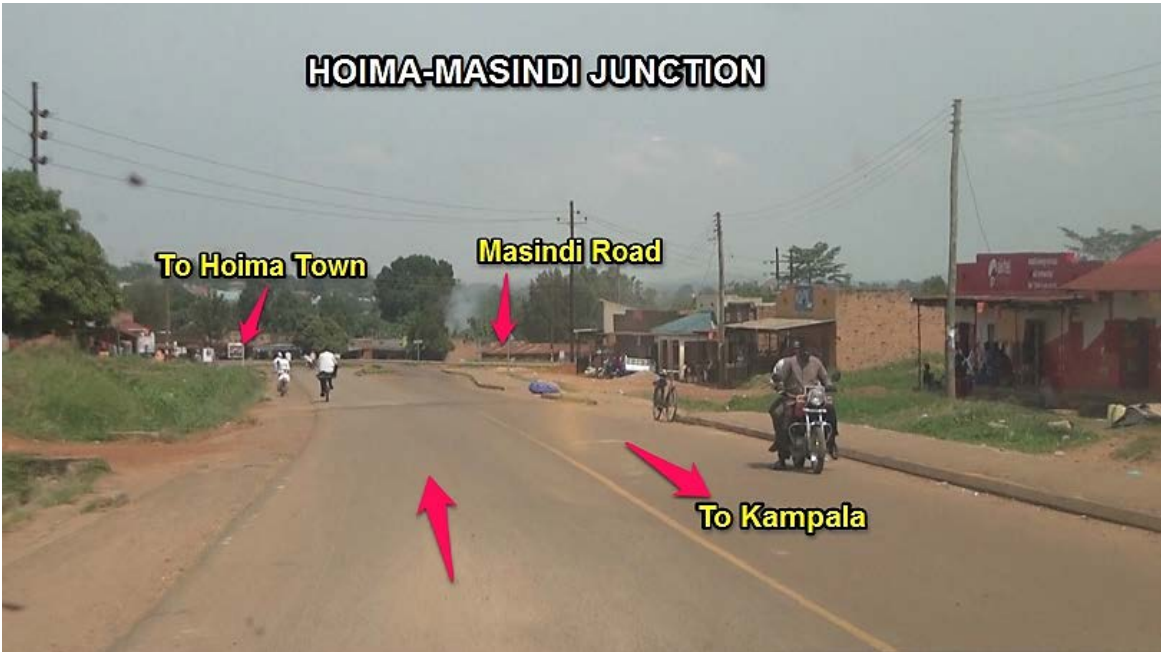
Figure 10: Photo plates illustrating risky spots along Kampala-Hoima Road

Section 2.6 shows location by distance from the Northern By-Pass of specific black spots along Kampala-Hoima Road. Figure 10 illustrates with photographs of some of the risk spots along the road. These blackspots make Kampala-Hoima road risky for new drivers to the road.
