Road Safety Inspection of the Kampala-Malaba Highway

A Baseline Study

Prepared by
Godfrey Mwesige
Safety and traffic engineer, Department of construction Economics and Management, MAKERERE UNIVERSITY
feedback@safewayrightway.org

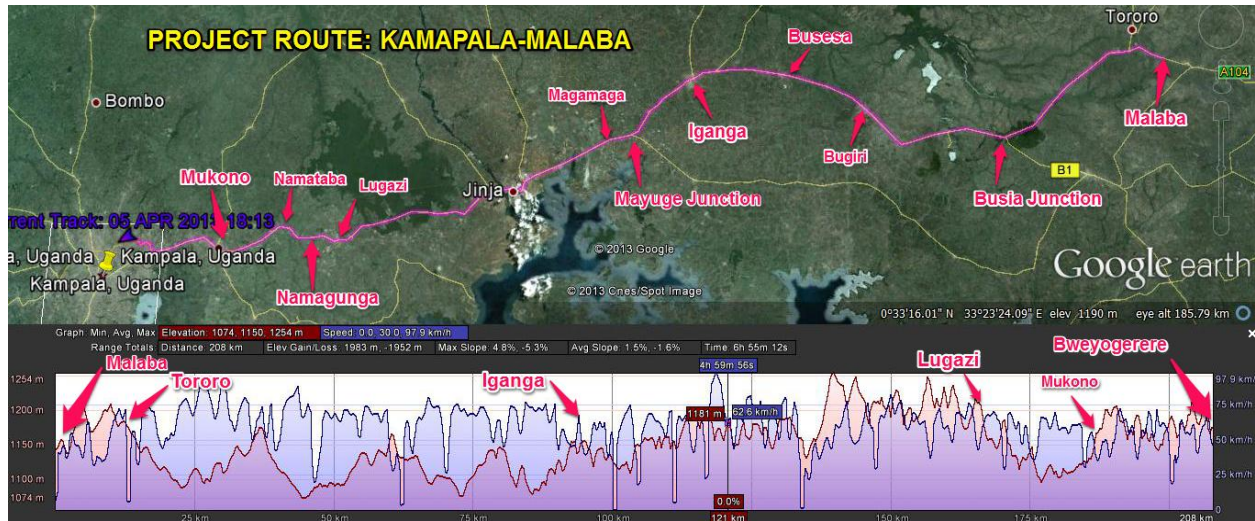
Figure 3: Track, Elevation and Speed Profile for Kampala-Malaba Highway (GPS track overlay on Google Earth Map)

The alignment profile of highway was obtained using GPS tracking between Malaba and Bweyogerere. The overlay of the track onto Google Earth Map is shown in [Figure 3](#) with elevation plots in red and speed profile in blue colour. General observation from the alignment profile is that there is a gradual reduction in elevation between Tororo (1144 m) and Iganga (1154m) and a rise thereafter to a peak of 1254 m near Nakibizi after Jinja Town. The elevations further drop between Lugazi and Mukono from 1216 m to 1201 m, and rise again up to Bweyogerere. The maximum, average and minimum vertical elevations are 1074 m, 1150 m and 1254 m respectively.

The fall and rise in elevations has an effect on the expected speeding characteristics of vehicles and a huge bearing on the type of accidents that occur. Low elevation between Tororo and Iganga makes the section a high speed as well as that between Lugazi and Mukono with a high likelihood of loss of control accidents. This can be observed from the speed profile in [Figure 3](#). Furthermore, there is a significant speed reduction between Iganga and Lugazi, and Mukono-Bweyogerere partly due to rise in elevation. Speed reduction increases the likelihood of fast

vehicles (mainly passenger cars) to overtake slow vehicles (mainly heavy vehicles) and therefore head-on accidents. If more head-on accidents were recorded by traffic police between Iganga and Lugazi should not be surprising. This will be checked against available accident statistics.

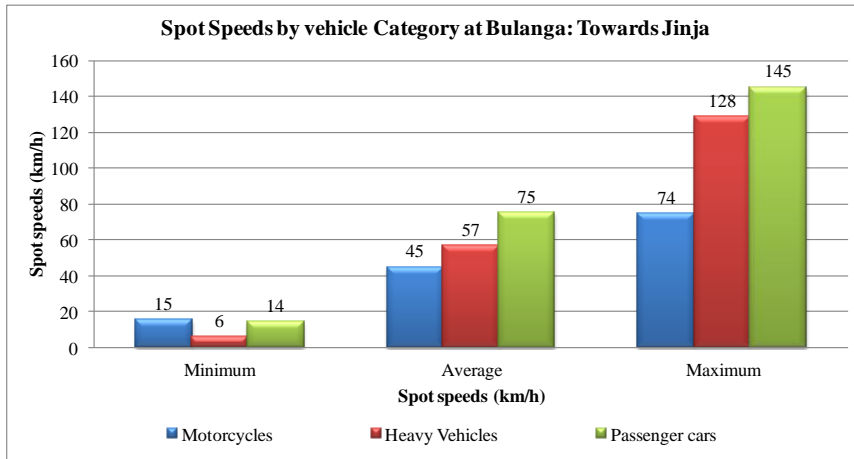
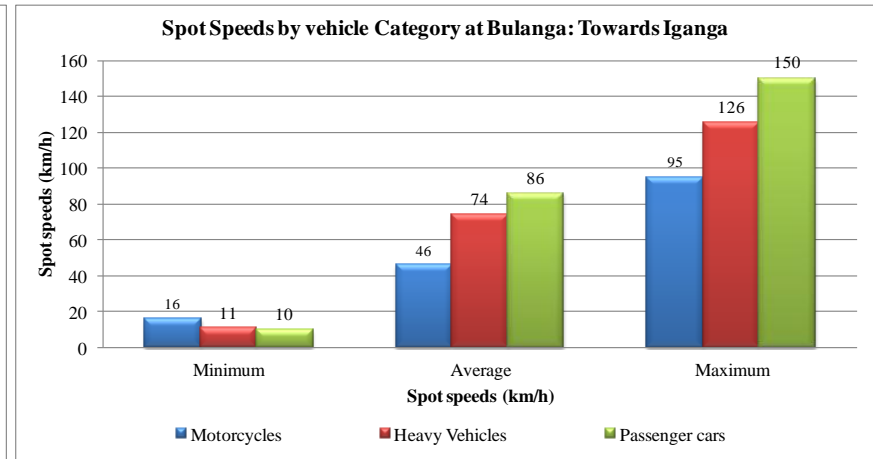
Figure 5: Spot Speeds by Vehicle Category in Two Directions at Bulanga

In traffic engineering perspective, the 85th percentile speed should be close or equal to speed limit for the highway. The 85th percentile speed for passenger cars at Bulanga by travel direction is 103 km/h (Towards Iganga) and 91 km/h (Towards Jinja). At Namasoga the 85th percentile speeds are 95 km/h (Towards Iganga) and 93 km/h (Towards Jinja). At Nakalama the 85th percentile speeds are 92 km/h (Towards Bugiri) and 91 km/h (Towards Iganga). At Busesa the 85th percentile speeds are 92 km/h (Towards Bugiri) and 92 km/h (Towards Iganga). The 85th percentile speeds of passenger cars at the four stations exceed the speed limit by 11-23 km/h. The conclusion from this finding from the data is that passenger cars grossly violate 80 km/h speed limit.

The above analysis shows that there is an existing problem of excessive speeds amongst passenger cars which is consistent at all the four stations in two directions. There is need for speed enforcement at high speed sections. Therefore enforcement measures should be directed towards making the speeding characteristics of passenger cars consistent and close to the speed limit of 80 km/h. The goal of the enforcement is to reduce observed 85th percentile speed of passenger cars by 10-15 km/h.

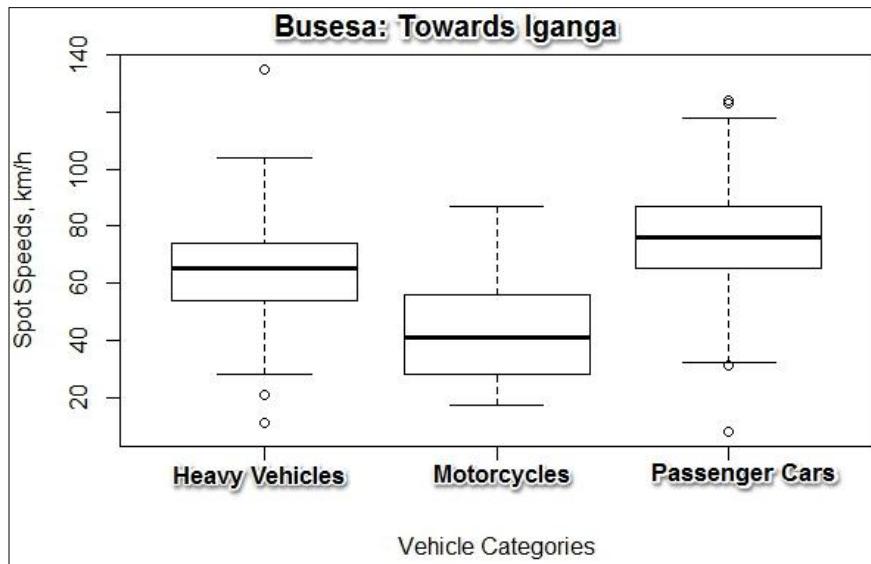
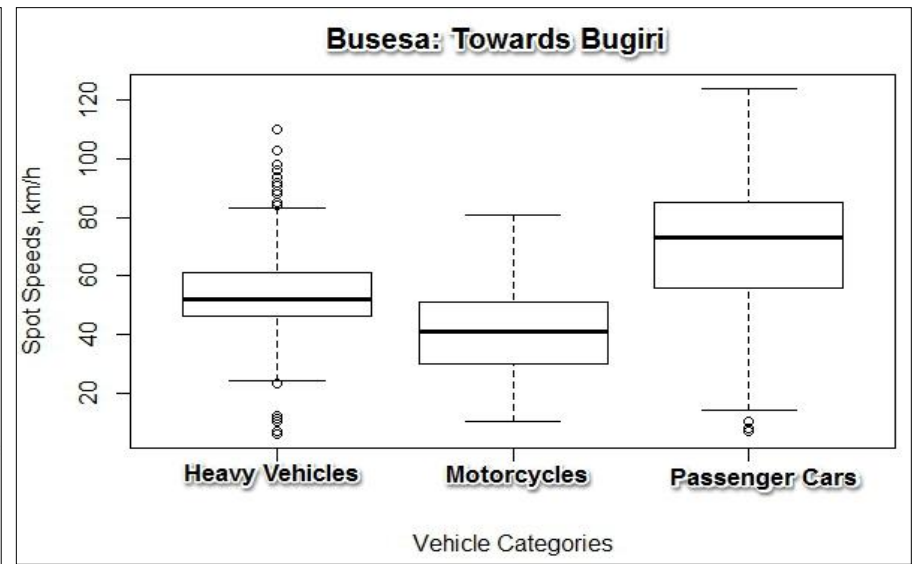
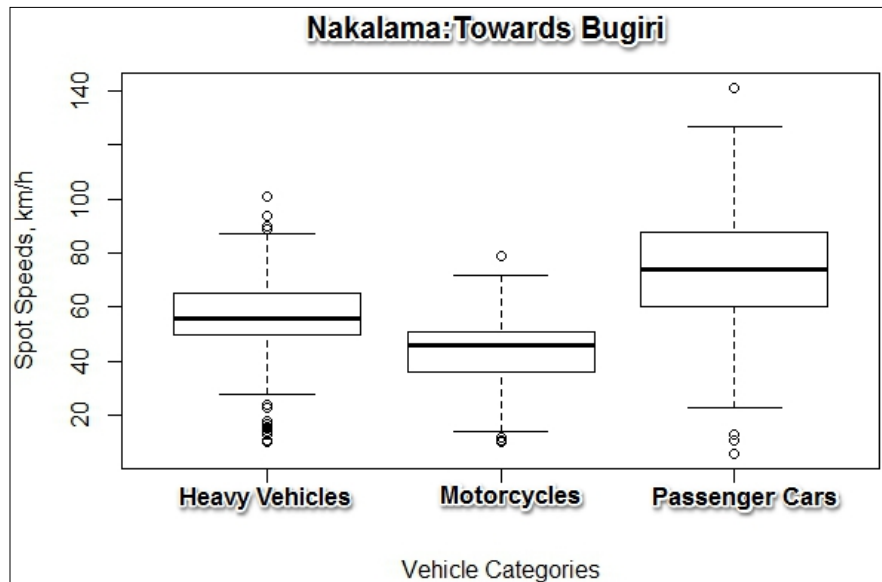
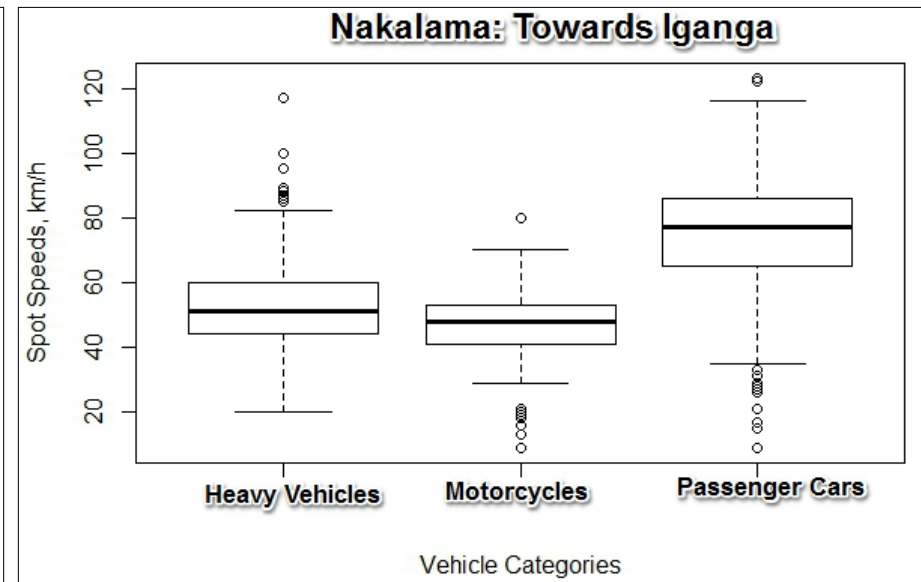
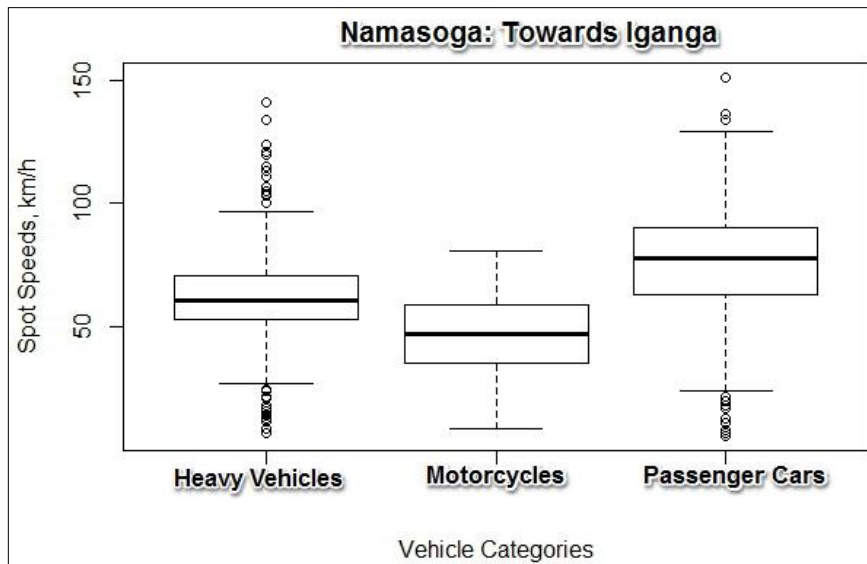
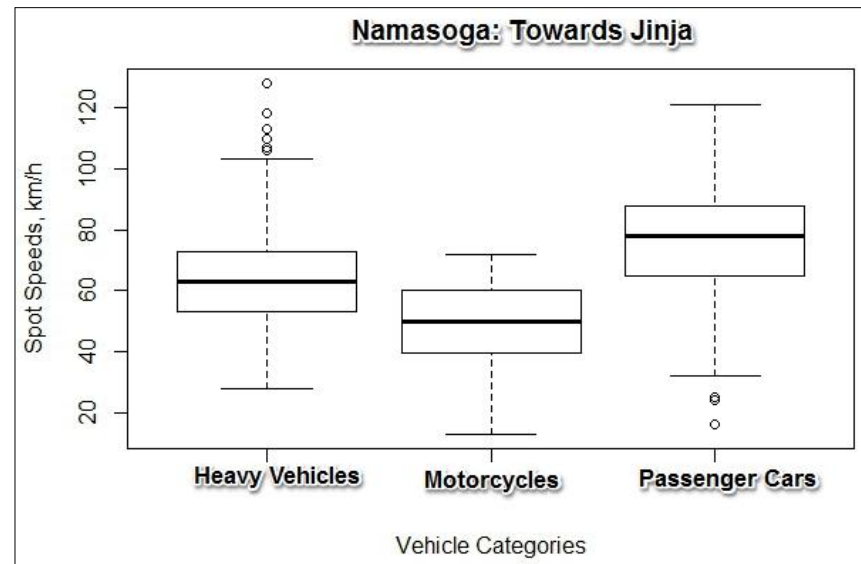
Figure 9: Boxplots for Speed Distribution by Vehicle Category

As a guide to interpreting the boxplot, the thick middle line shows location of the mean, lower and upper lines of the rectangle show the 25th and 75th percentile speeds respectively. 75th percentile speeds indicate the speed not exceeded by 75% of observed vehicles. That is, only 25% of observed vehicles had speeds in excess of 75th percentile speed. The width of the rectangle shows how variable the speeds are for the vehicle category. The dotted vertical line shows the upper extent of normal speeds. Values above this line show speeds in excess of normal speeds for the vehicle category, also referred to statistically as outliers or simply put excessive

speeds. Note in the plots that the mean speed of passenger cars is consistently higher than the other two, and more variable due to wider rectangle. Passenger cars have outliers representing excessive speeds. The 75th percentile speed is above 80 km/h indicating with certainty that 25% of all observed passenger cars had speeds in excess of the speed limit.

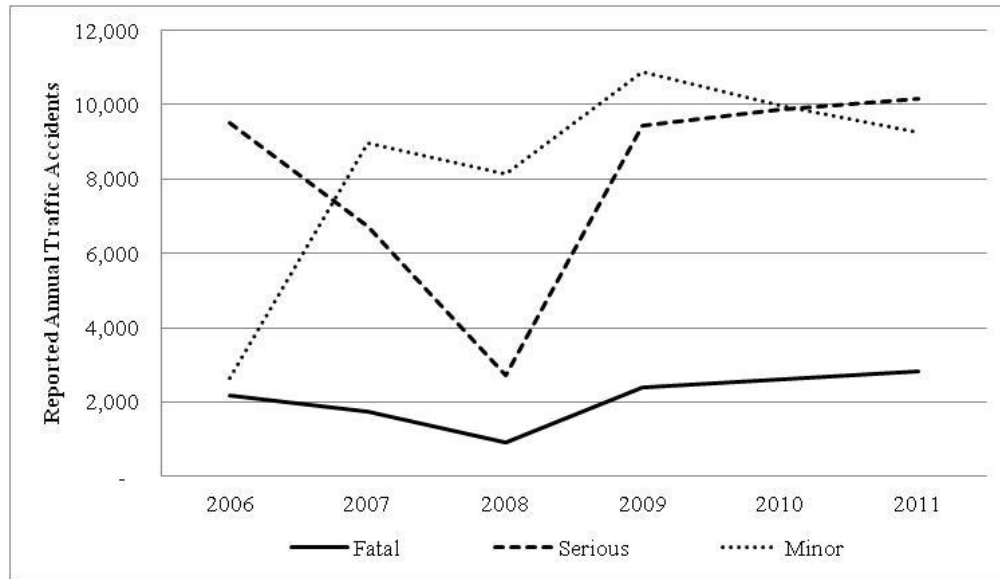
Figure 10: Reported Annual Traffic Accident Statistics by Uganda Police Force (Statistical Abstract 2010, 2011 & 2012)

National traffic accident data from Uganda Police Force for the period 2006-2011 shows a gradual increase in the total number of reported accidents by severity; fatal, serious and minor injury (Figure 10). Particularly, fatal and serious injury accidents have mostly been attributed to over speeding, reckless/dangerous driving; careless driving and dangerous loading (see Table 1). The year 2008 shows a dip across three severities. This could be attributed to safety actions carried out by Uganda Police Force that year such as enforcing the speed limit and highway patrol.
